Manhole Inspection Summary

Manhole # S35EE_008MH

Insp Date: **3/5/07 12:52 PM**

Location Address: **1232 PRESTON ST**

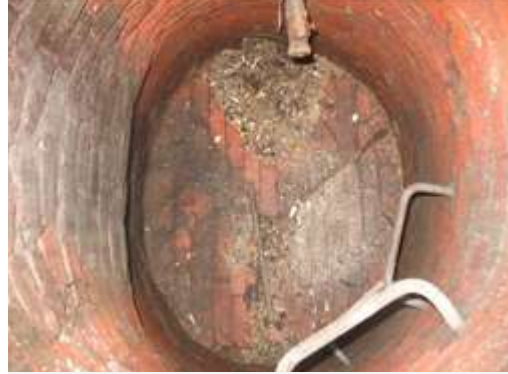
Top View

Channel debris. Valve.

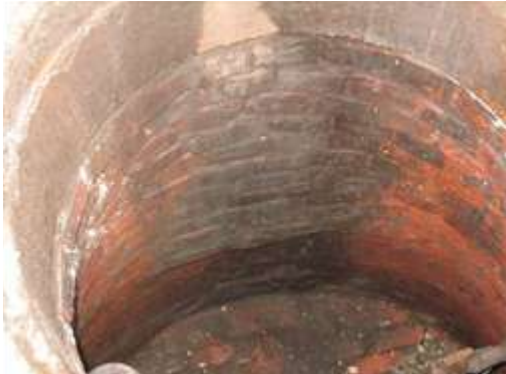
Defect

☒ **Leaks**

Infiltration: ☐ None ☒ **Joint** ☐ Cracks ☒ **Mortar** ☐ Roots ☐ Wall

Infiltration: ☐ None ☐ Joint ☐ Cracks ☐ Mortar ☐ Roots ☒ **Wall**

Frame leaks. Adjustment and Barrel infiltration.

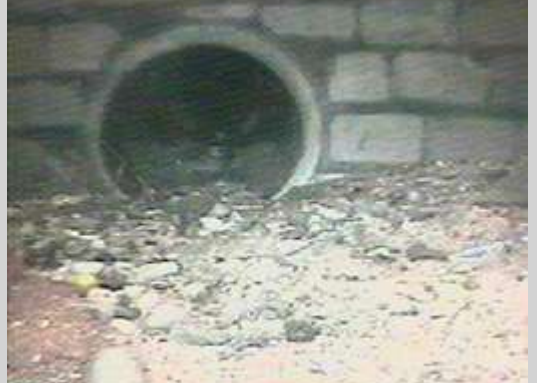
8 in. Circular Gravity Sewer
Pipe Out @ 12 O'Clock

Rod and Bar (Angled)

Deposits: ☐ None ☒ **Mud** ☐ Sludge ☒ **Debris** ☐ Grease

Silt Depth: **1** (in.) Deposits Extent: **Light**

Infiltration: **Evidence** Pipe Seal Cond: **Unknown**
